# Arboricultural Impact Assessment

Risby Street, Ulverstone, 2024

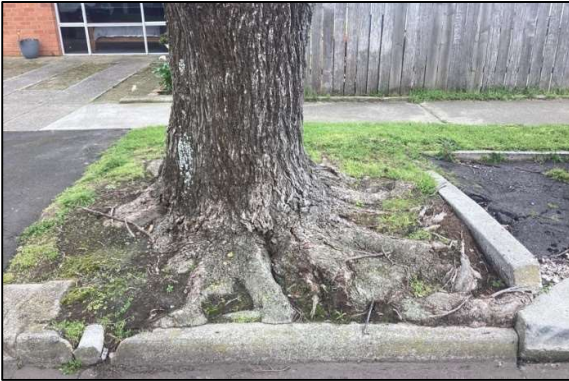
**Image 1** – Show the restricted growing environment of Tree 1. Note the disruption to surrounding infrastructure.

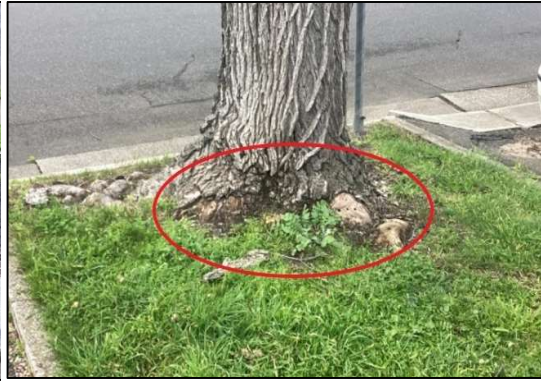
Structurally, most elms were rated as "poor" or "fair." Notably, trees 1 and 2 exhibited 10mm diameter drill holes in their root plates, which could indicate poisoning. Tree 2 also showed significant dieback, evidenced by large-diameter deadwood (over 100mm) scattered throughout its crown.

**Image 2** – Shows the western side of Tree 2. The red circle indicates the location of the 10mm Ø drill holes.

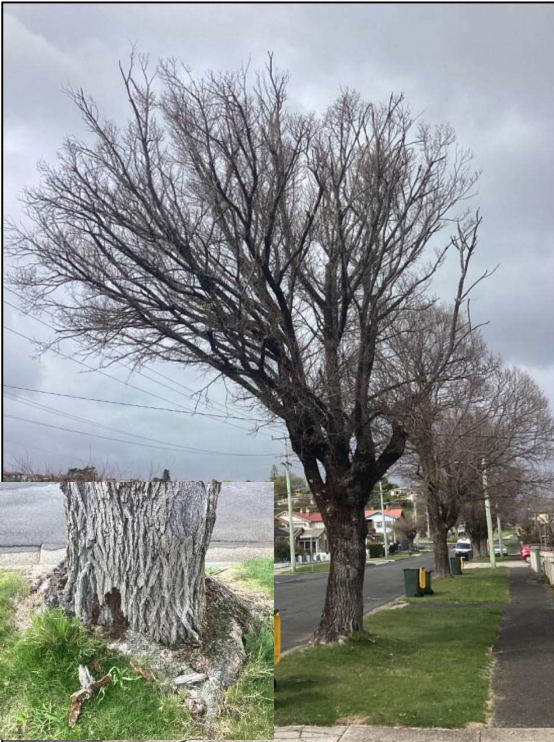
Trees 9 and 23 demonstrated more severe structural concerns, with longitudinal columns of dieback affecting more than one-third of the trunk diameter, extending into major structural branches. These conditions compromise these trees' stability and long-term survival, reducing their retention suitability.

**Image 3** – Shows Tree 9. Note significant deadwood throughout the crown. Insert shows a large girdling root and peeling bark indicative of vascular necrosis.

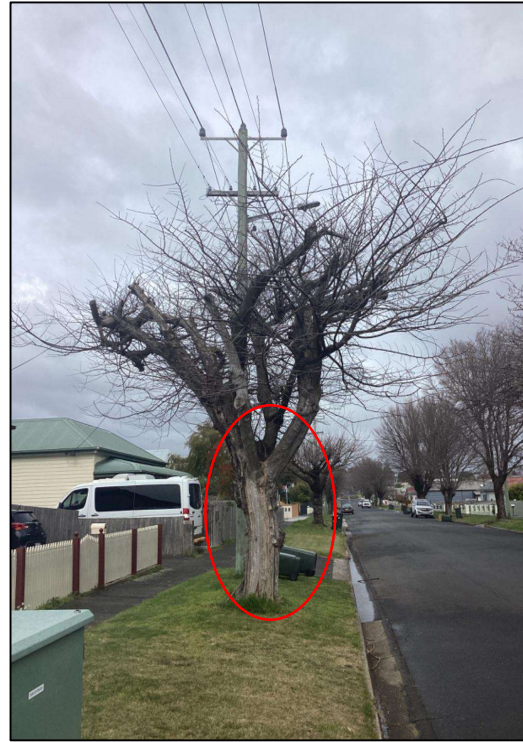
**Image 4** – Shows Tree 23. The circled area indicates the northern aspect of the trunk, where all vascular tissue has died. Note the proximity of the NBN box from the tree.

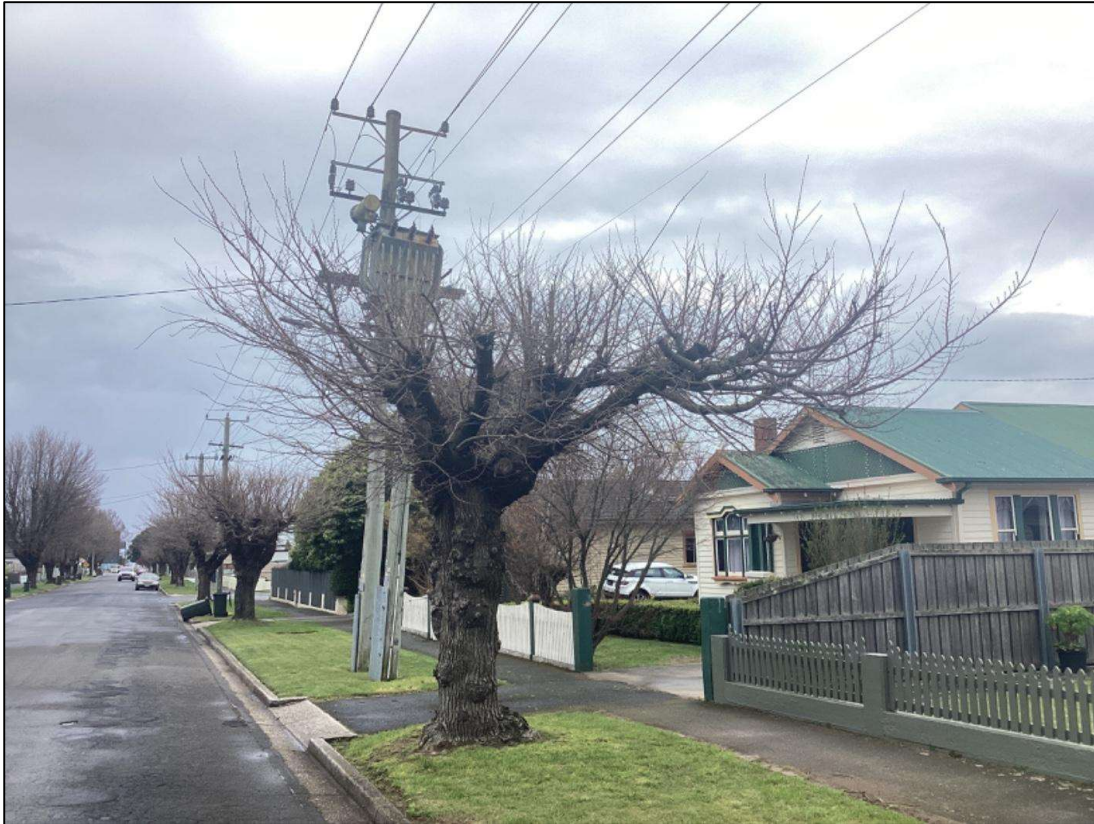
Low- and high-voltage powerlines run along the street's eastern side, requiring significant clearance and pruning of the trees on this side to maintain safe distances from the lines. These powerlines and clearance requirements have notably influenced the growth patterns and structural condition of the trees on the street's eastern side.

**Image 5** – Shows Tree 16 and other trees on the eastern side of the road that were heavily lopped to provide clearance from the powerlines above.

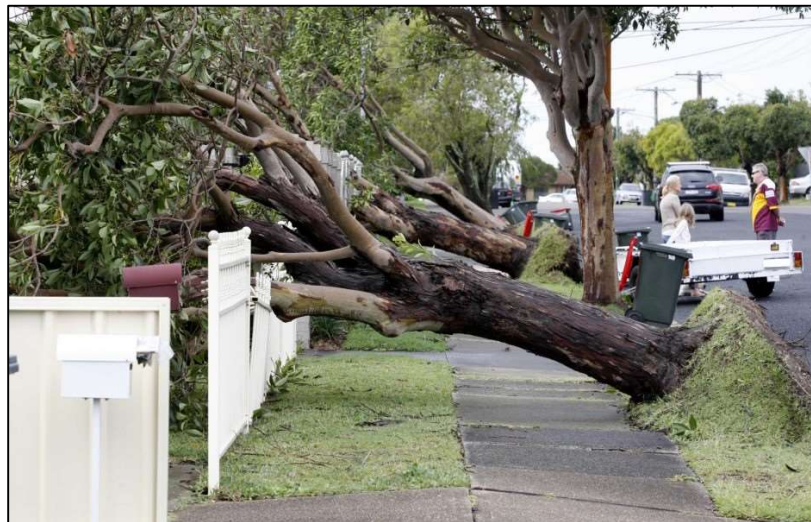
**Image 6** – The failure of Brush Box trees in Sydney during strong winds in 2015 highlights the severe consequences of restricted growing environments combined with root severance.
