## Application for Planning

Application No.: **DA2023255**

Location: **Harveys Road (CT131560/2), North Motton**

Proposal: **Residential - single dwelling**

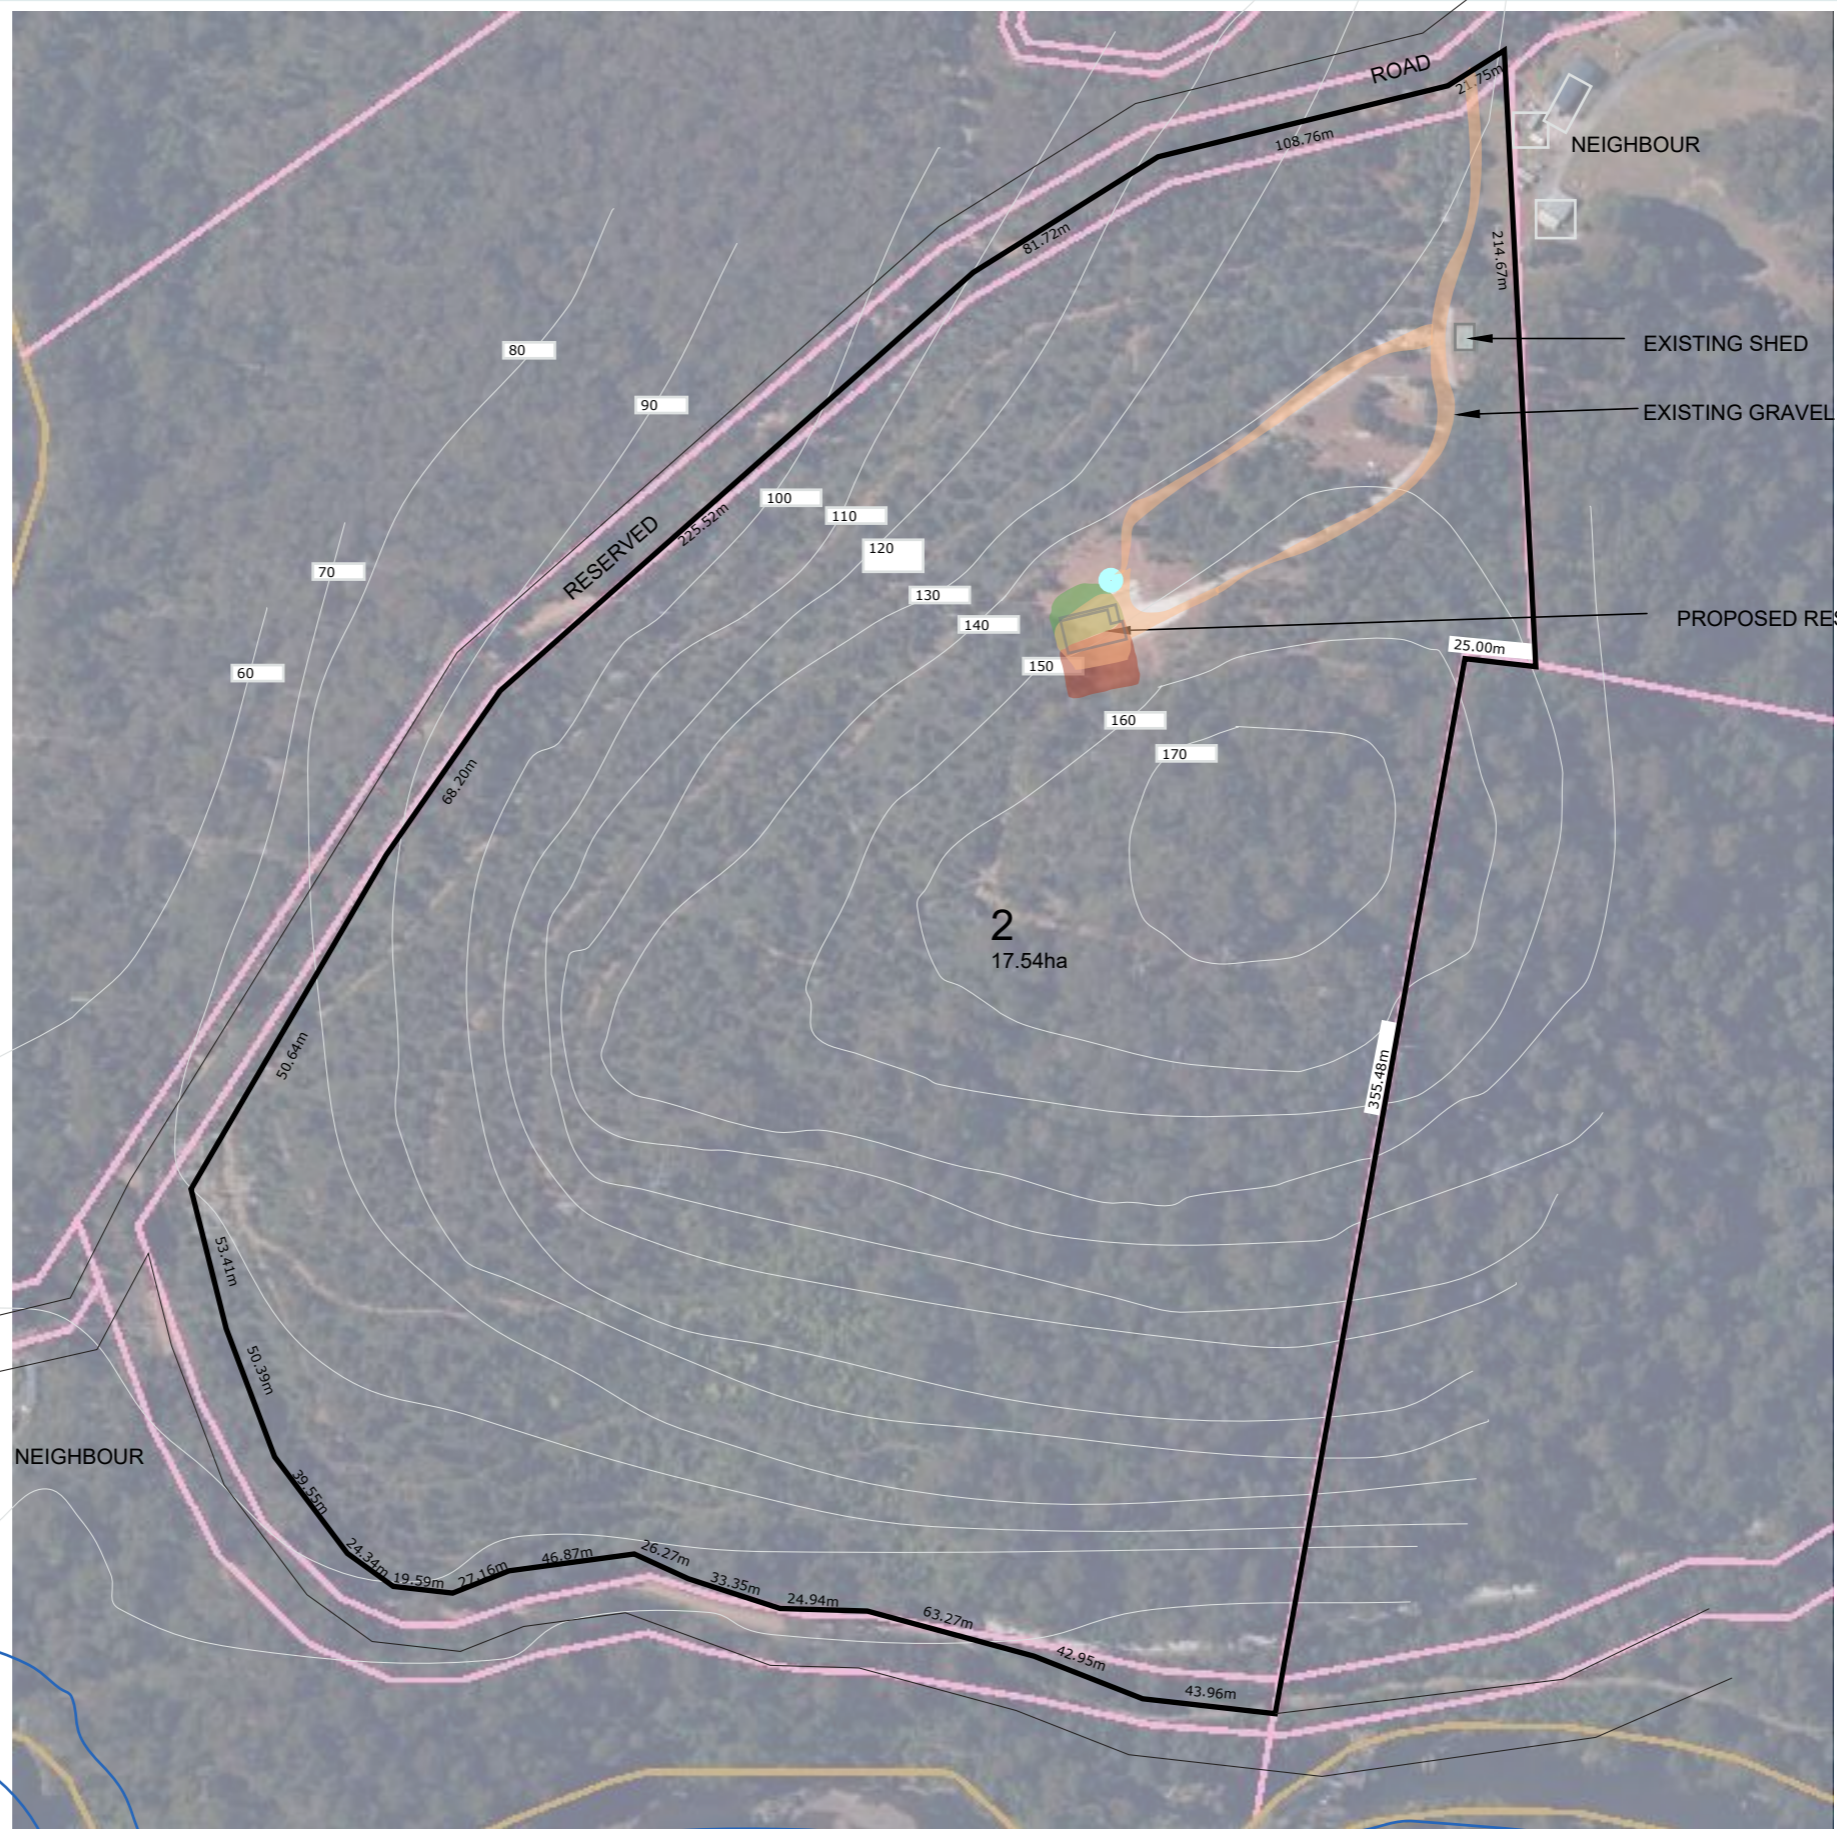
**A01**

NO SERVICES AVAILABLE FOR THE SITE

Site Plan  
 Scale: 1 : 2500

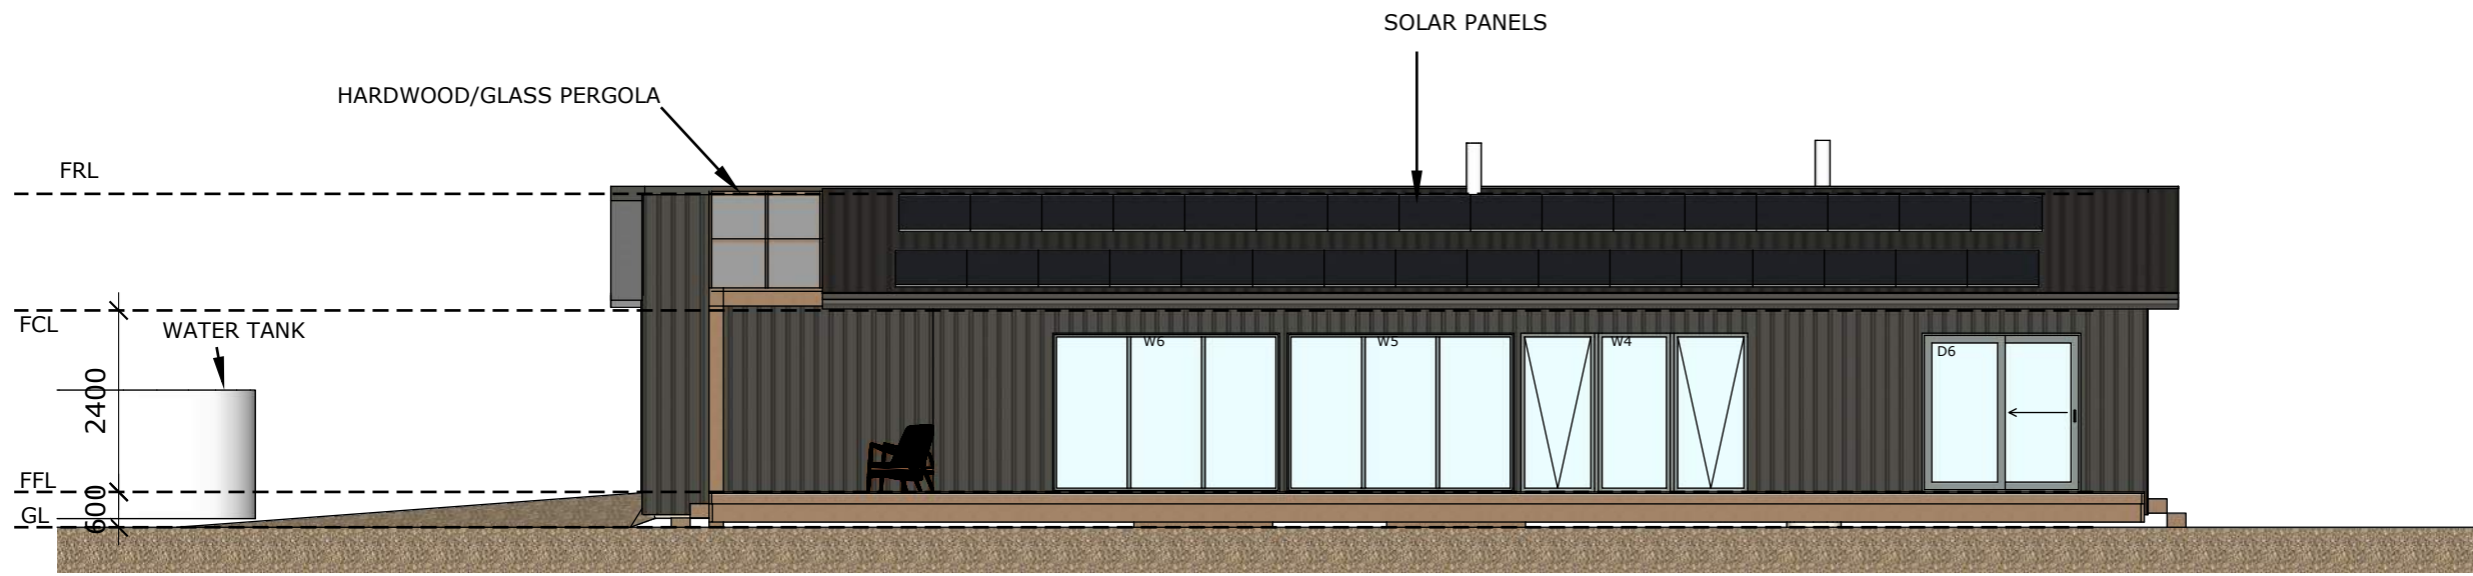
1 North Elevation  
Scale: 1 : 100

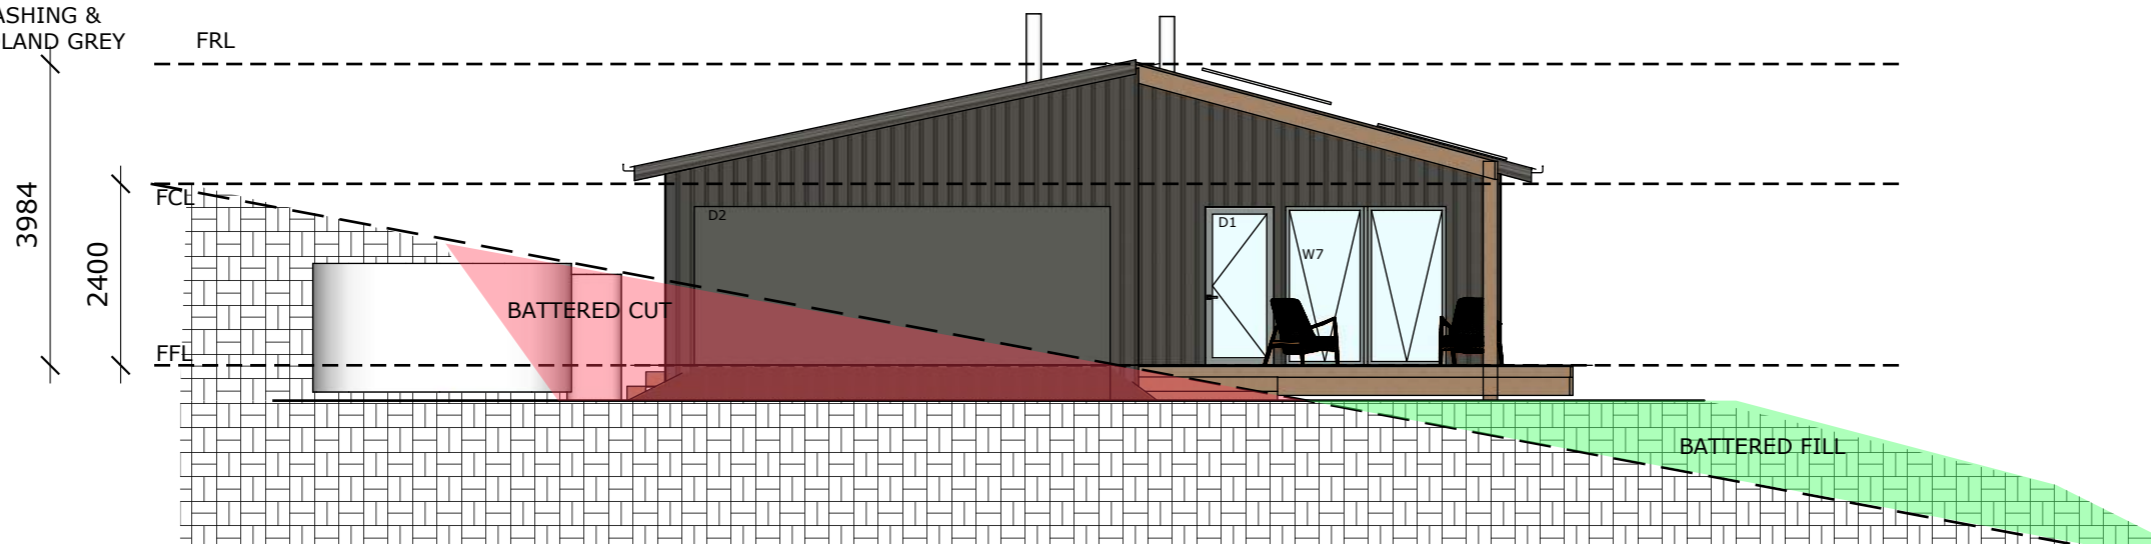
2 East Elevation  
Scale: 1 : 100

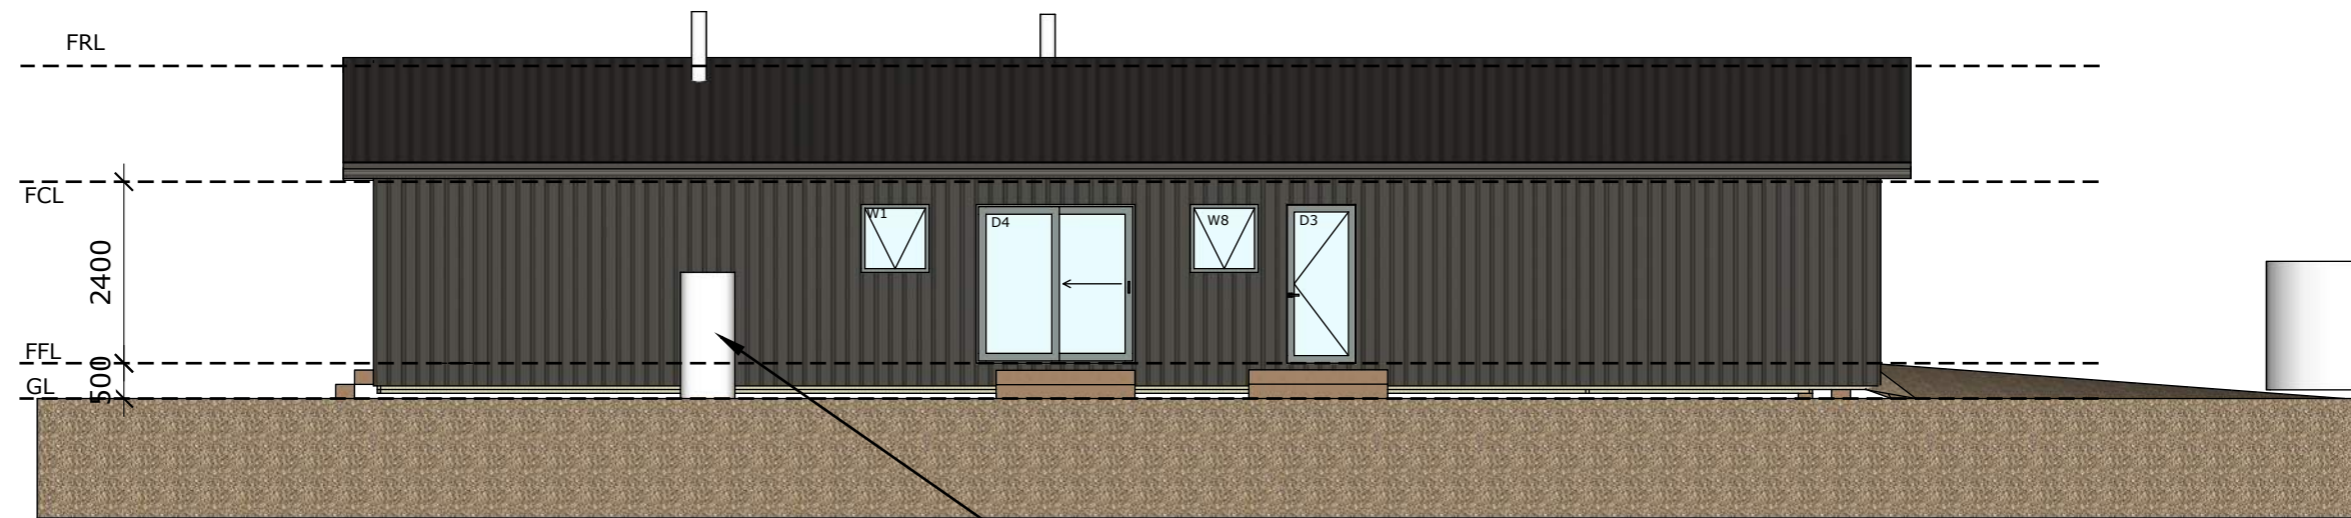
-   TRIMDEK CLADDING IN WOODLAND GREY
-   HARDWOOD DECKING, SEALED
-   COLORBOND FLASHING & TRIMS IN WOODLAND GREY

3 South Elevation  
Scale: 1 : 100

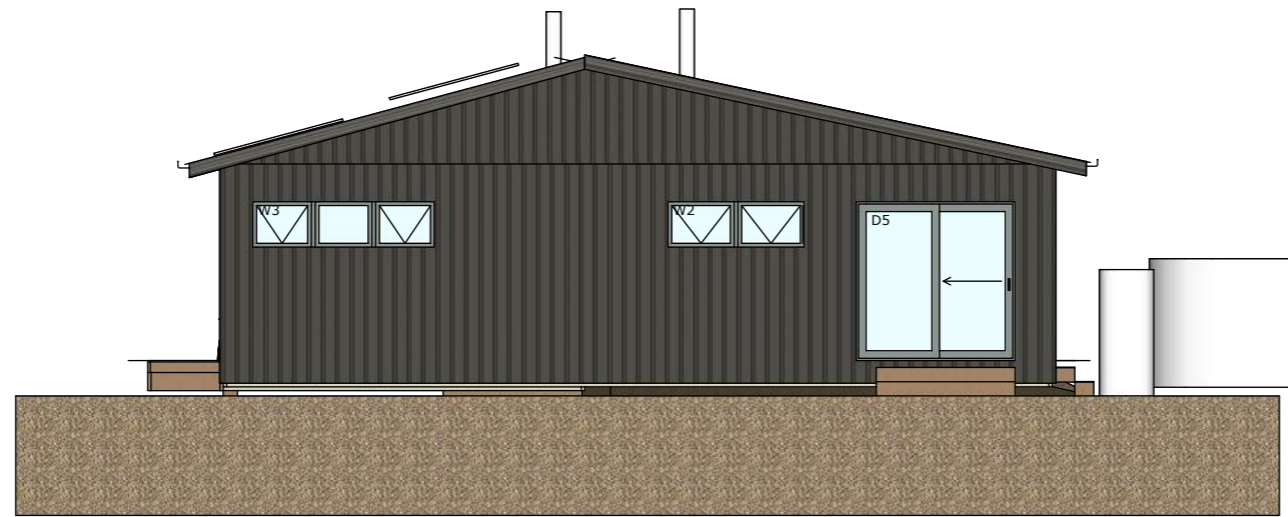
4 West Elevation  
Scale: 1 : 100

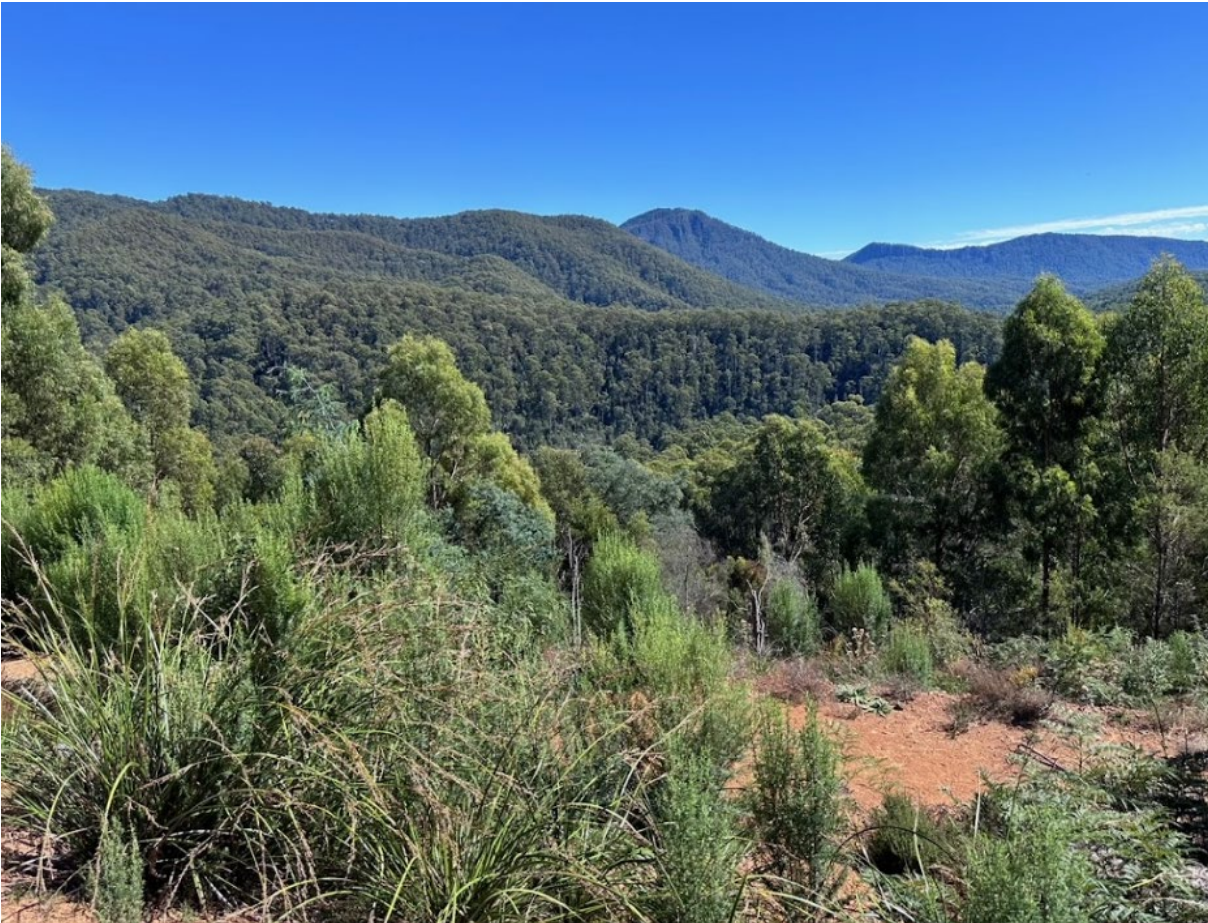
Image 3 – North: Forest vegetation. This area has previously been cleared, being at regrowth stage.

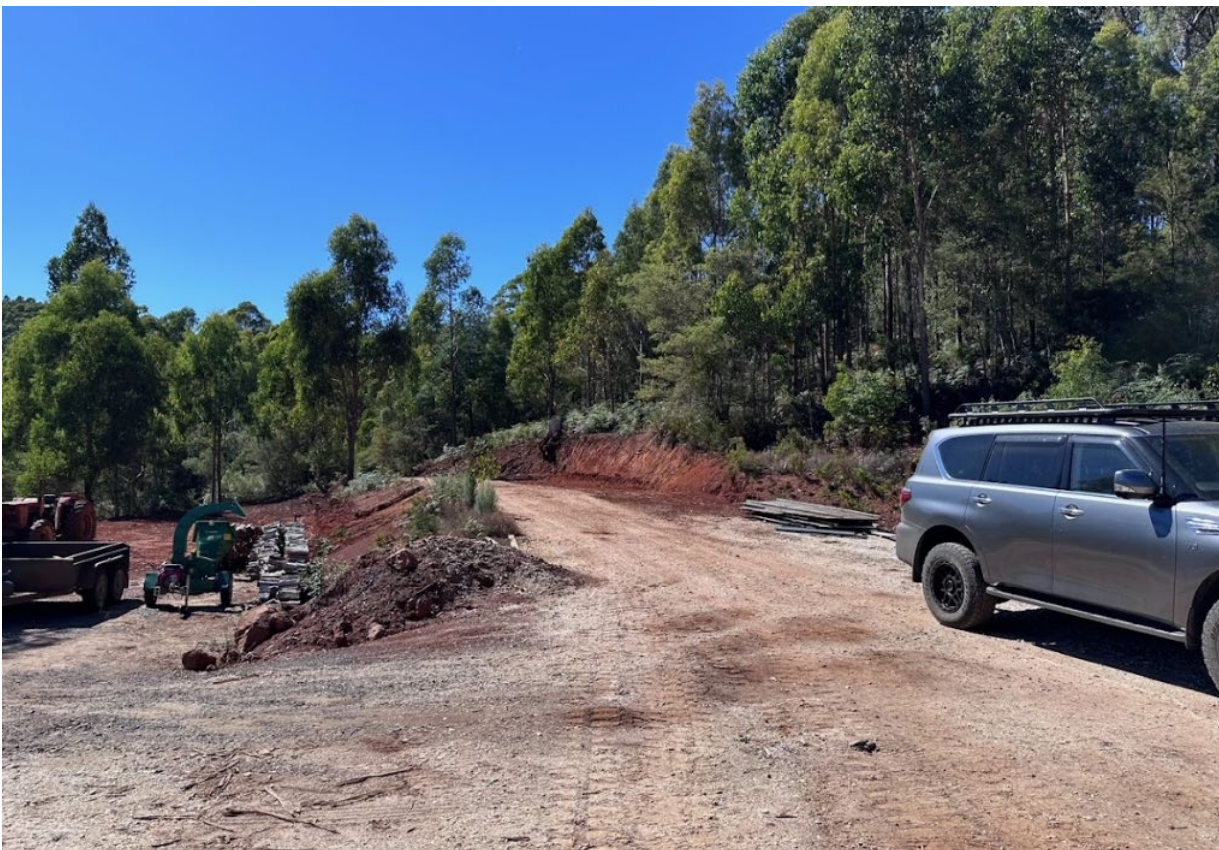
Image 4 – East: – Cleared land then forest vegetation.

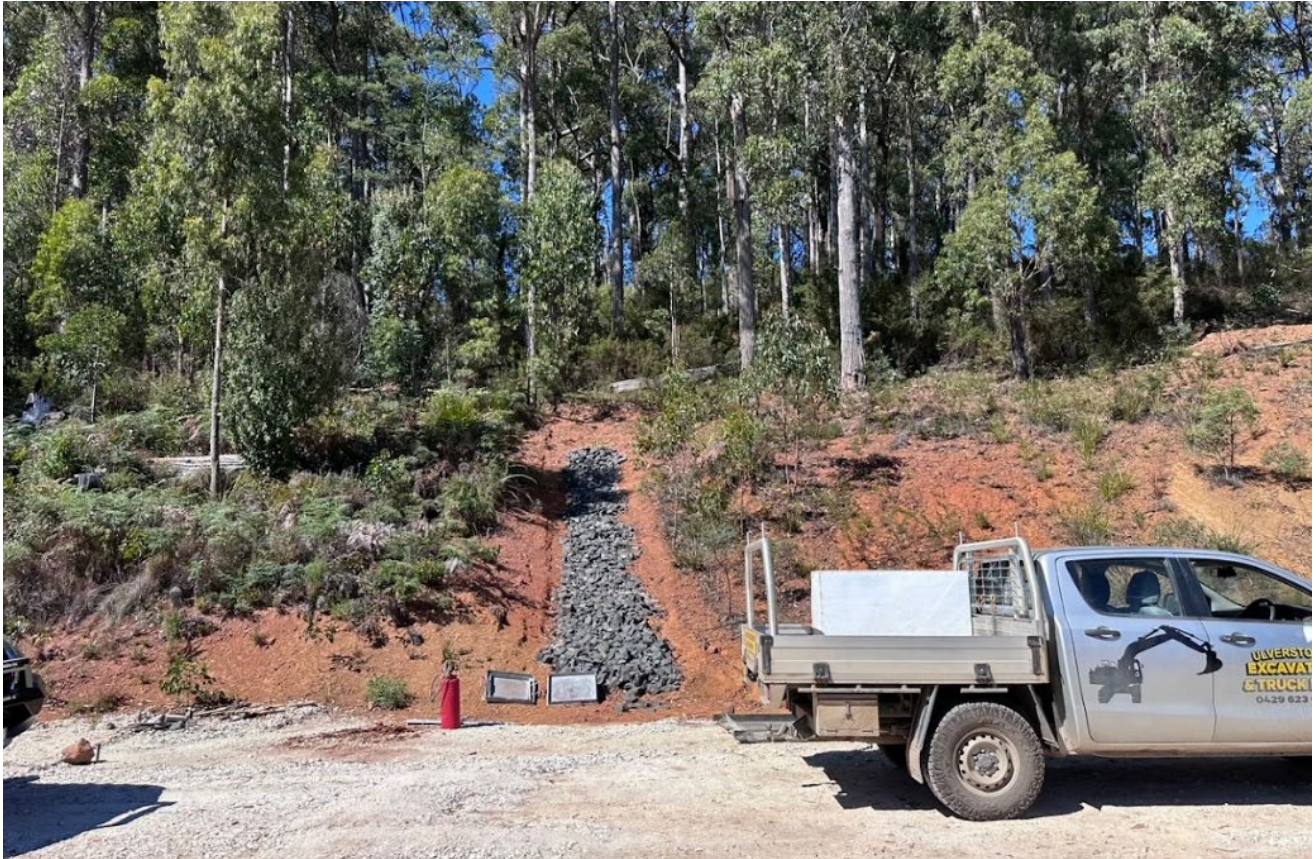
Image 5 – South: Forest vegetation.

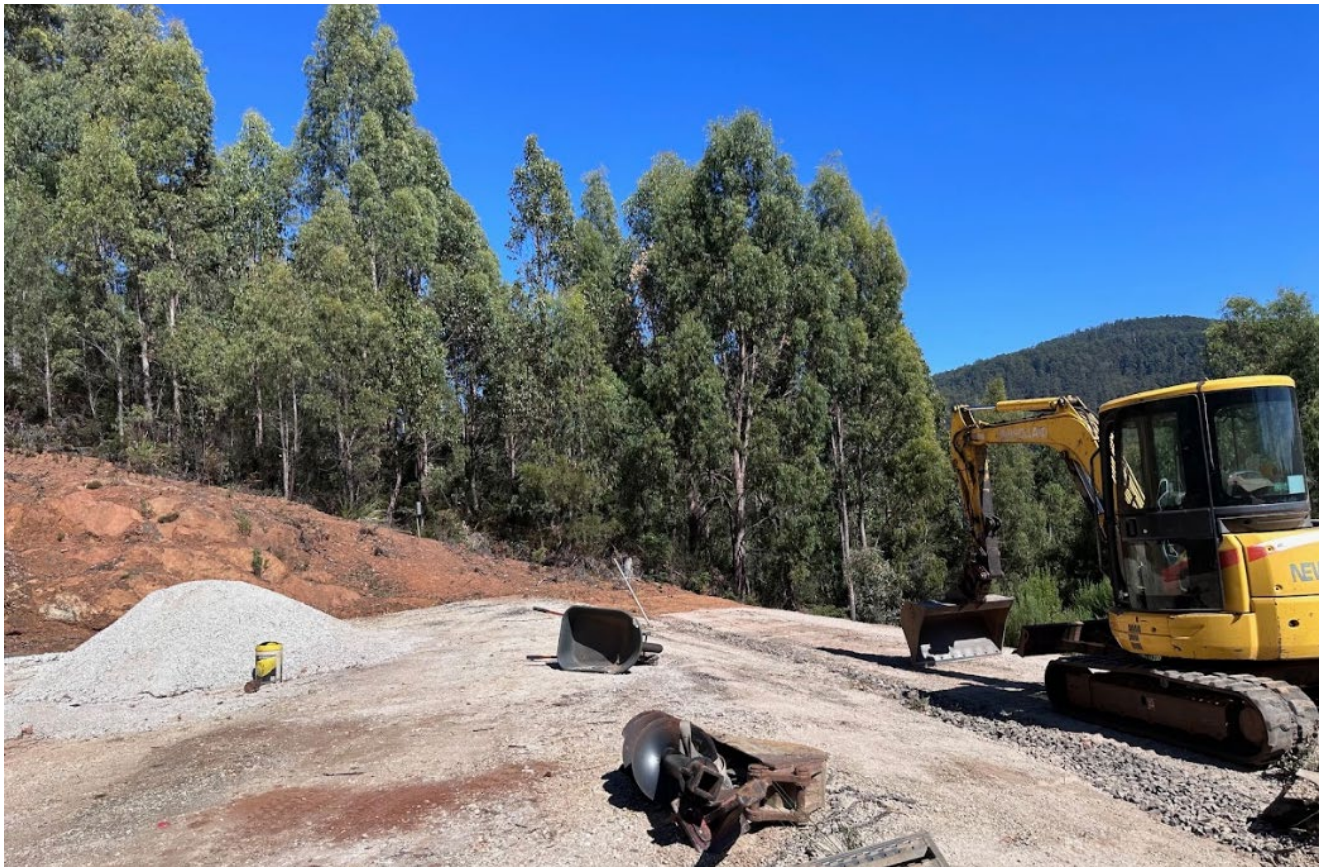
Image 6 – West: Forest vegetation.

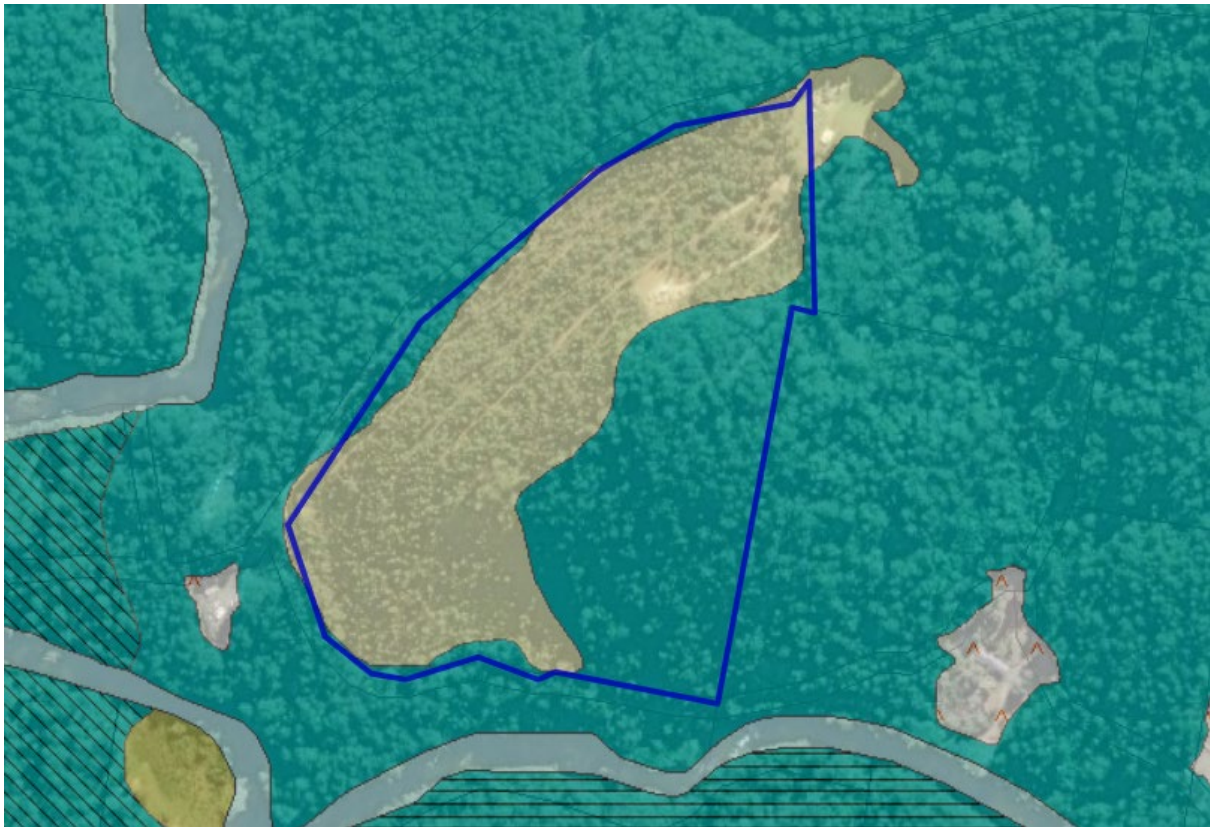
Image 7: Source Listmap - TasVeg 4.0

The layer covering the development site is a mix of (WOB) Wet eucalyptus obliqua forest (shown in green) and (FAG) agricultural land, which is not regrown into modified land, being regrowth Forst.

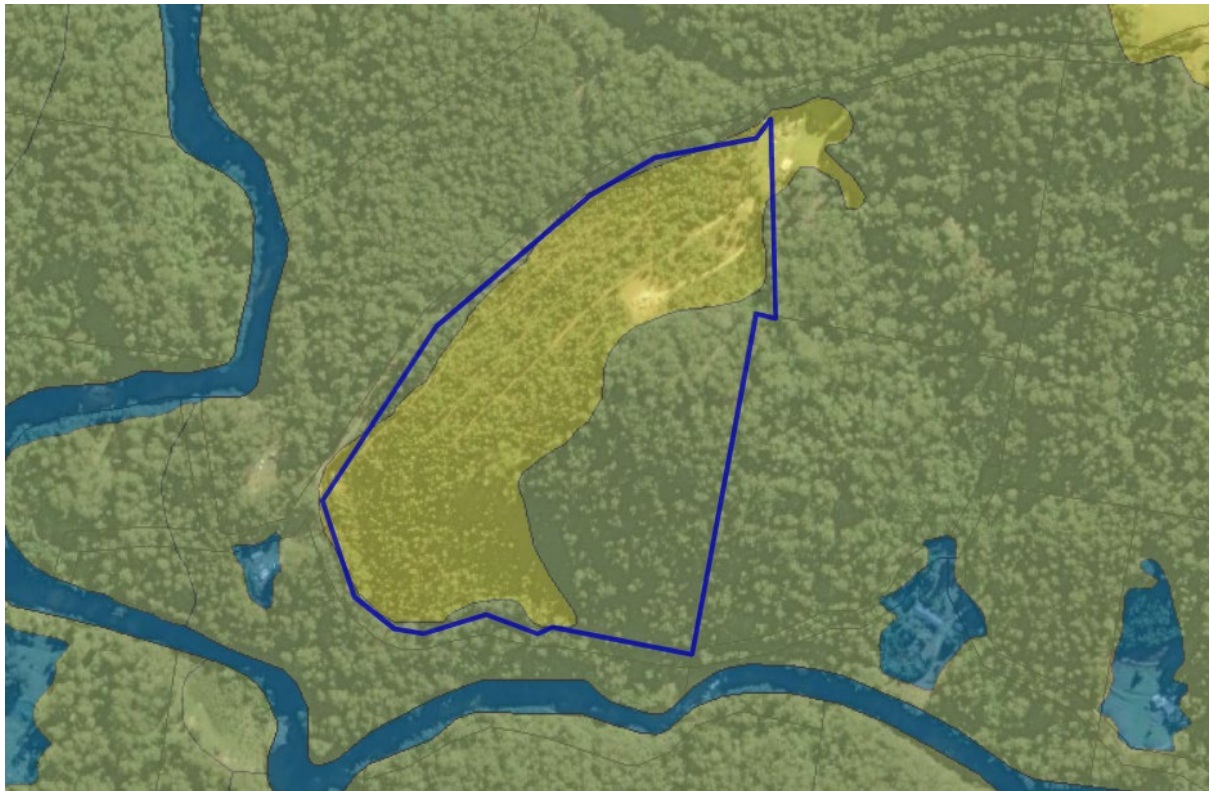
Image 8: Source Listmap - TasVeg 4.0 Fire Attributes

Land shown in yellow has a medium to high flammability and low sensitivity, while land shown in green has a medium to high flammability and high sensitivity.

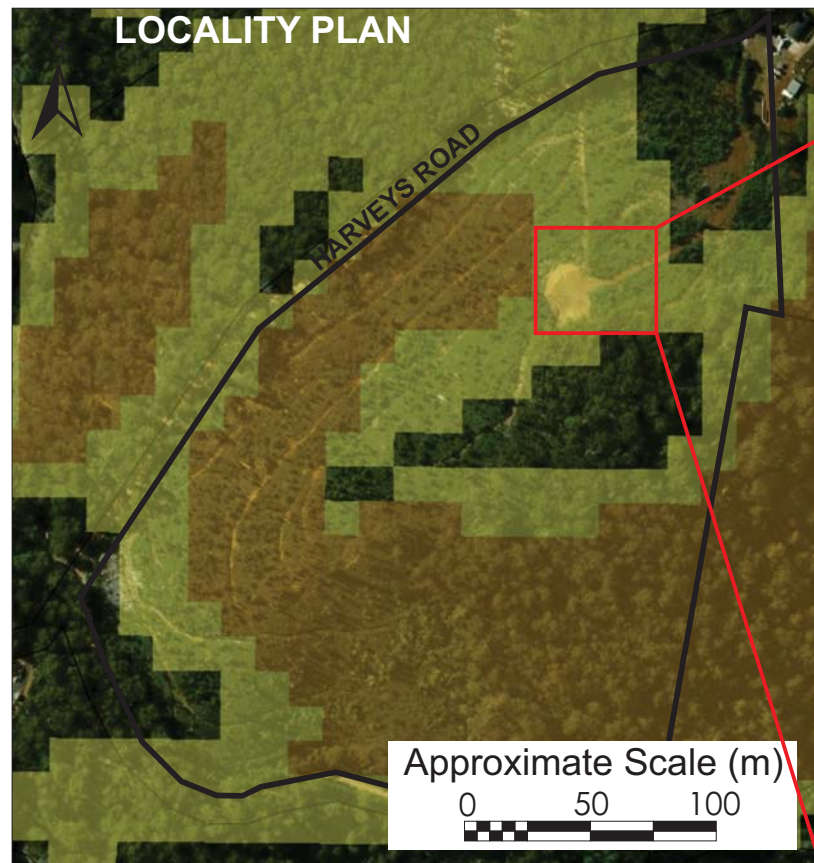
- TP 1 Approximate Test Pit Location
- 5° Approximate Slope Angle
- Approximate Change in Slope
- Medium Landslide Hazard Band
- Low Landslide Hazard Band
- Proposed Dwelling
- Approximate area of fill
- Approximate area of cut

Examination of the LIST Landslide Planning Map – Hazard Bands, indicates that the slopes downslope to the northwest of the proposed development area are mapped within a medium landslide hazard band. The proposed development area (including the wastewater disposal area) is mapped within a low landslide hazard band.

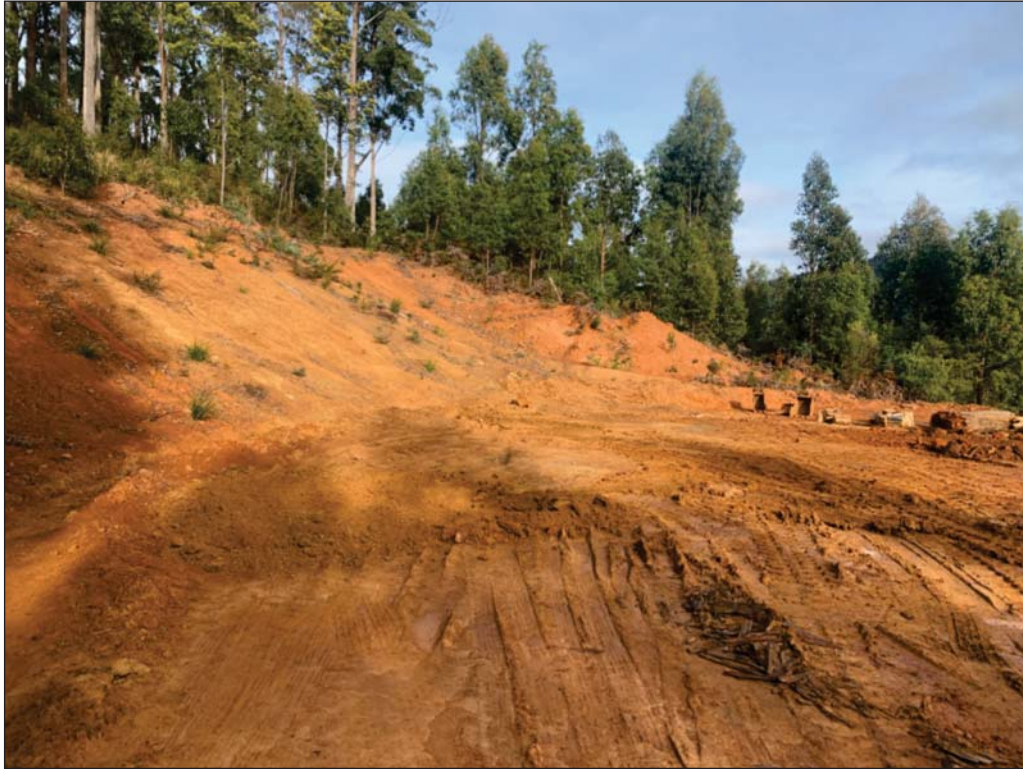
**PLATE 1 - Looking southwest at the proposed building envelope and the cut batter above the site**

The cut batter above the proposed dwelling is approximately 3m high with a uniform slope of 26°. The cut batter was in a good condition and typically consisted of clayey silt soils overlying extremely weathered material and highly weathered rock.

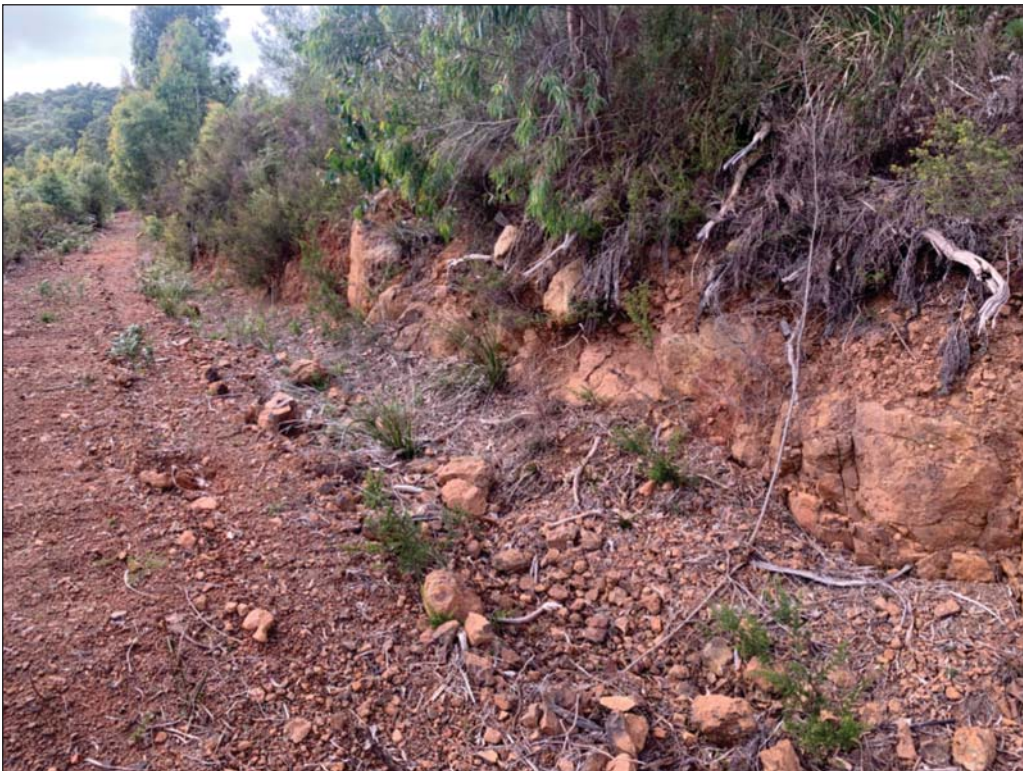
**PLATE 2 - Looking east at insitu rock outcrops located below the proposed dwelling**

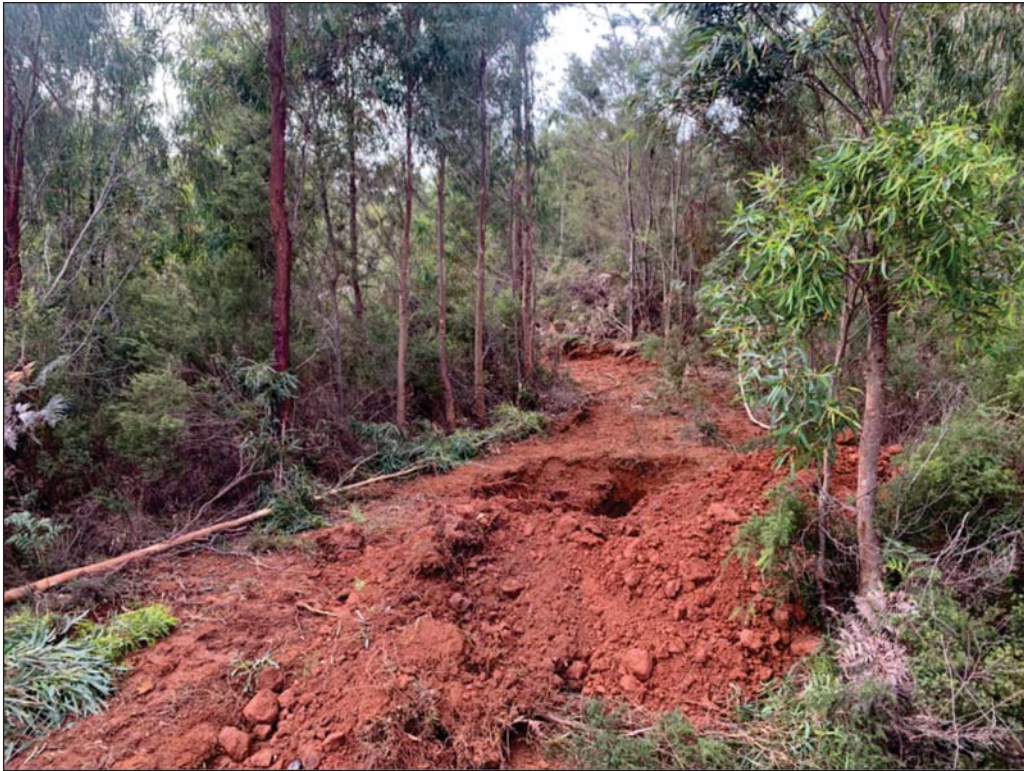
**PLATE 3 - Looking northeast at the proposed wastewater disposal field**

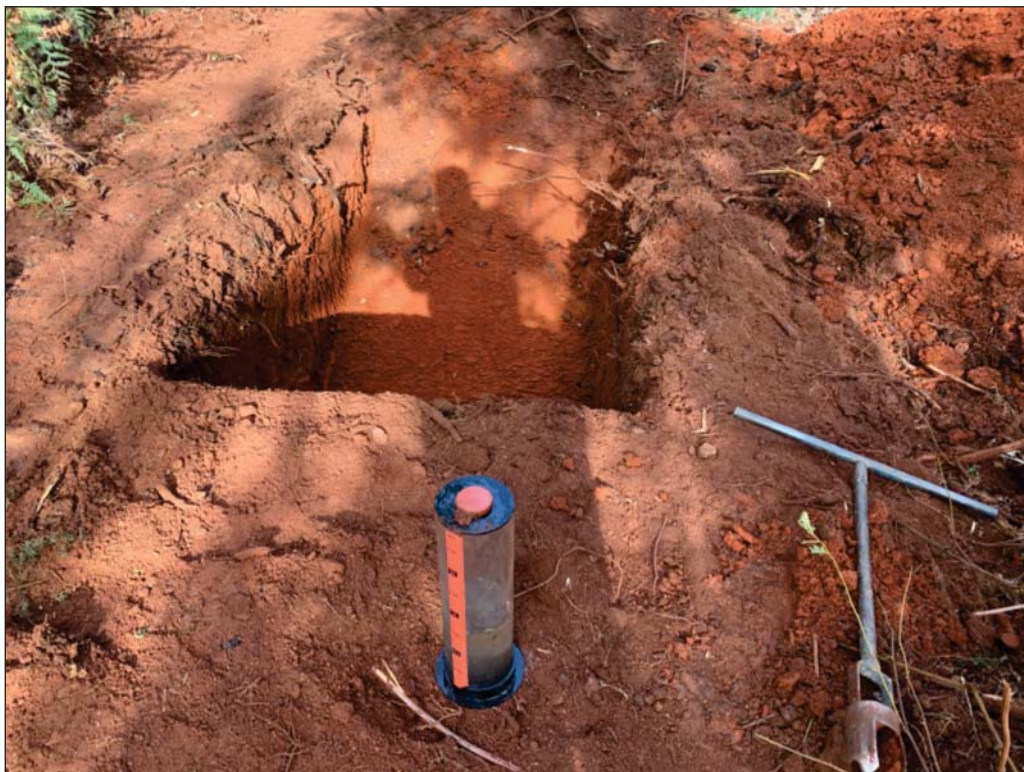
**PLATE 4 - Test Pit TP5 (located within the proposed wastewater field)**
