Central Coast Public Toilet Plan 2013–2023

June 2013

CENTRAL COAST COUNCIL

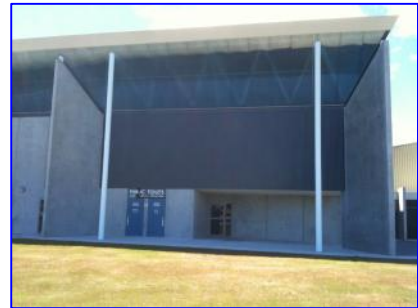
Ulverstone Sports and Leisure Centre toilet

- Four are for public use only with only external access
 - Ulverstone Sports and Leisure Centre
 - Ulverstone Wharf
 - Ulverstone Football Ground (Robin's Roost)
 - Carpark Lane Facilities
 - Beach Road, Ulverstone
- One is for both for public and pavilion users with external and internal access.
 - North Motton Reserve

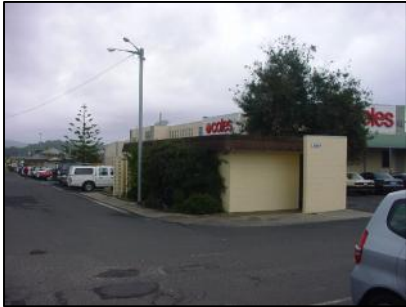
The older traditional types of toilet do not meet today's needs and standards and require refurbishment or replacement

From the analysis it can also be seen that that the Coles Carpark toilets are over servicing the CBD area of Ulverstone and should be decommissioned, demolished and not replaced.

However due to the high use in this area it is recommended when these toilets are due for renewal (2014–2015) they be replaced with a smaller two cubicle, unisex, disabled compliant toilet. It has been determined that this would be sufficient to accommodate the usage. Due to a much smaller footprint this will also allow for a reconfiguration of the car park and enhance the circulation of traffic within this car park.

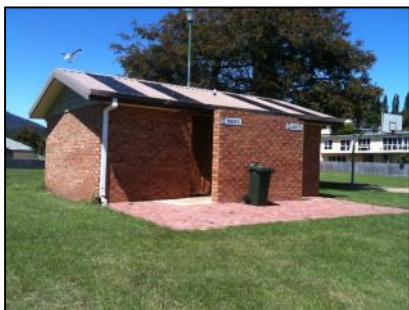
Hiscutt Park toilets

The older traditional types of toilet do not meet today's needs and standards and require refurbishment or replacement

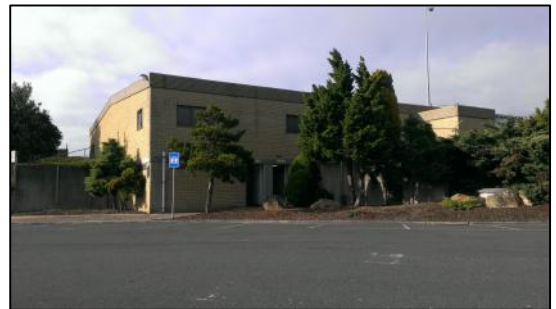
(a) Vegetation works trimming

This generally involves trimming or removal of vegetation that obscures the toilet or entrances to the toilet or could lead to concealment by a person hiding in the vegetation.

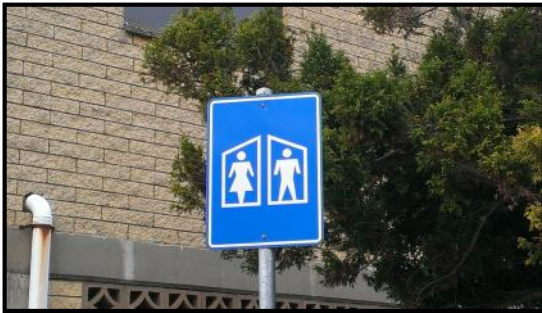
To assist, it is proposed to install more directional signage at various locations on the main roads approaching the toilet locations.

To do this a combination of 20 additional 'Public Toilet' street signs are required (as shown above).

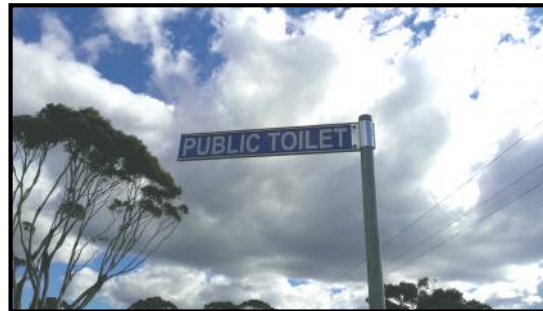
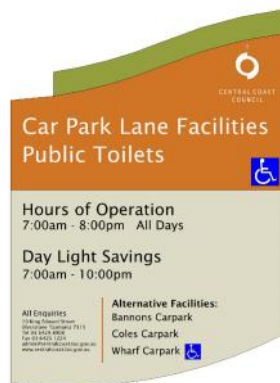
The type of sign adopted for this is shown below.

As can be seen these signs will contain information on the toilet name, hours of operation, nearest alternative facility, disabled compliant etc.

For each of these signs the cost to fabricate and erect is approximately \$500 therefore a total cost for all toilets would be approx. \$20,000.

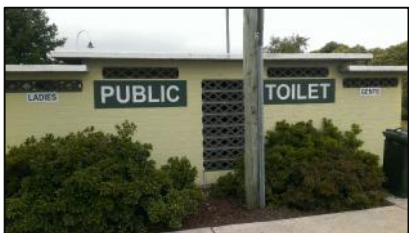
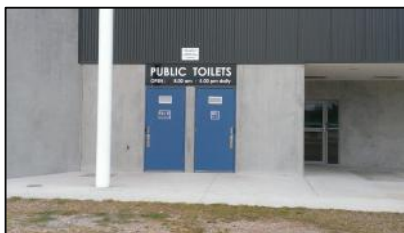
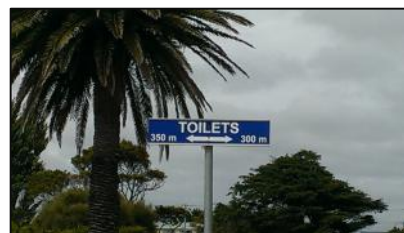
Examples of public toilet signage

Also below are some other examples of directional and facility signage used in Central Coast.

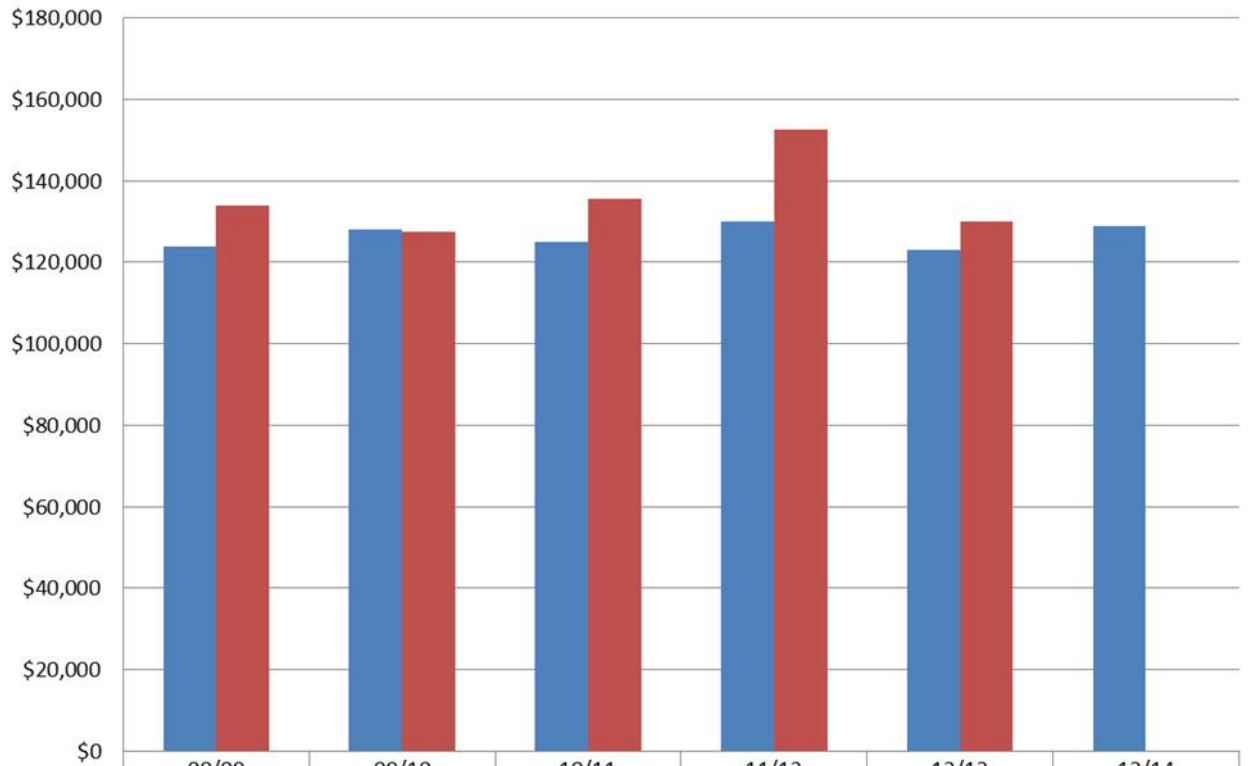
Public Toilet - Cleaning Costs

Cleaning - Budget	\$124,000	\$128,000	\$125,000	\$130,000	\$123,000	\$129,000
Actual Expenditure	\$134,000	\$127,500	\$135,500	\$152,500	\$130,000

Based on the 2012–2013 expenditure figure it costs \$3,421/toilet/annum to clean, \$2,500/toilet/annum to maintain and \$631/toilet/annum for vandalism repairs giving a total of \$6,553/toilet/annum.

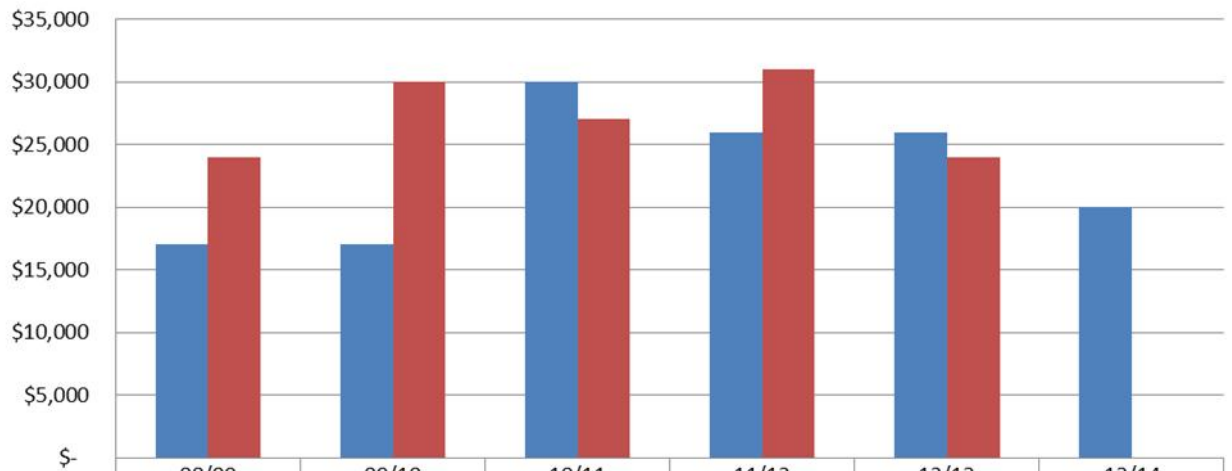
Public Toilets - Vandalism Costs

Vandalism - Budget	\$17,000	\$17,000	\$30,000	\$26,000	\$26,000	\$20,000
Actual Expenditure	\$24,000	\$30,000	\$27,000	\$31,000	\$24,000

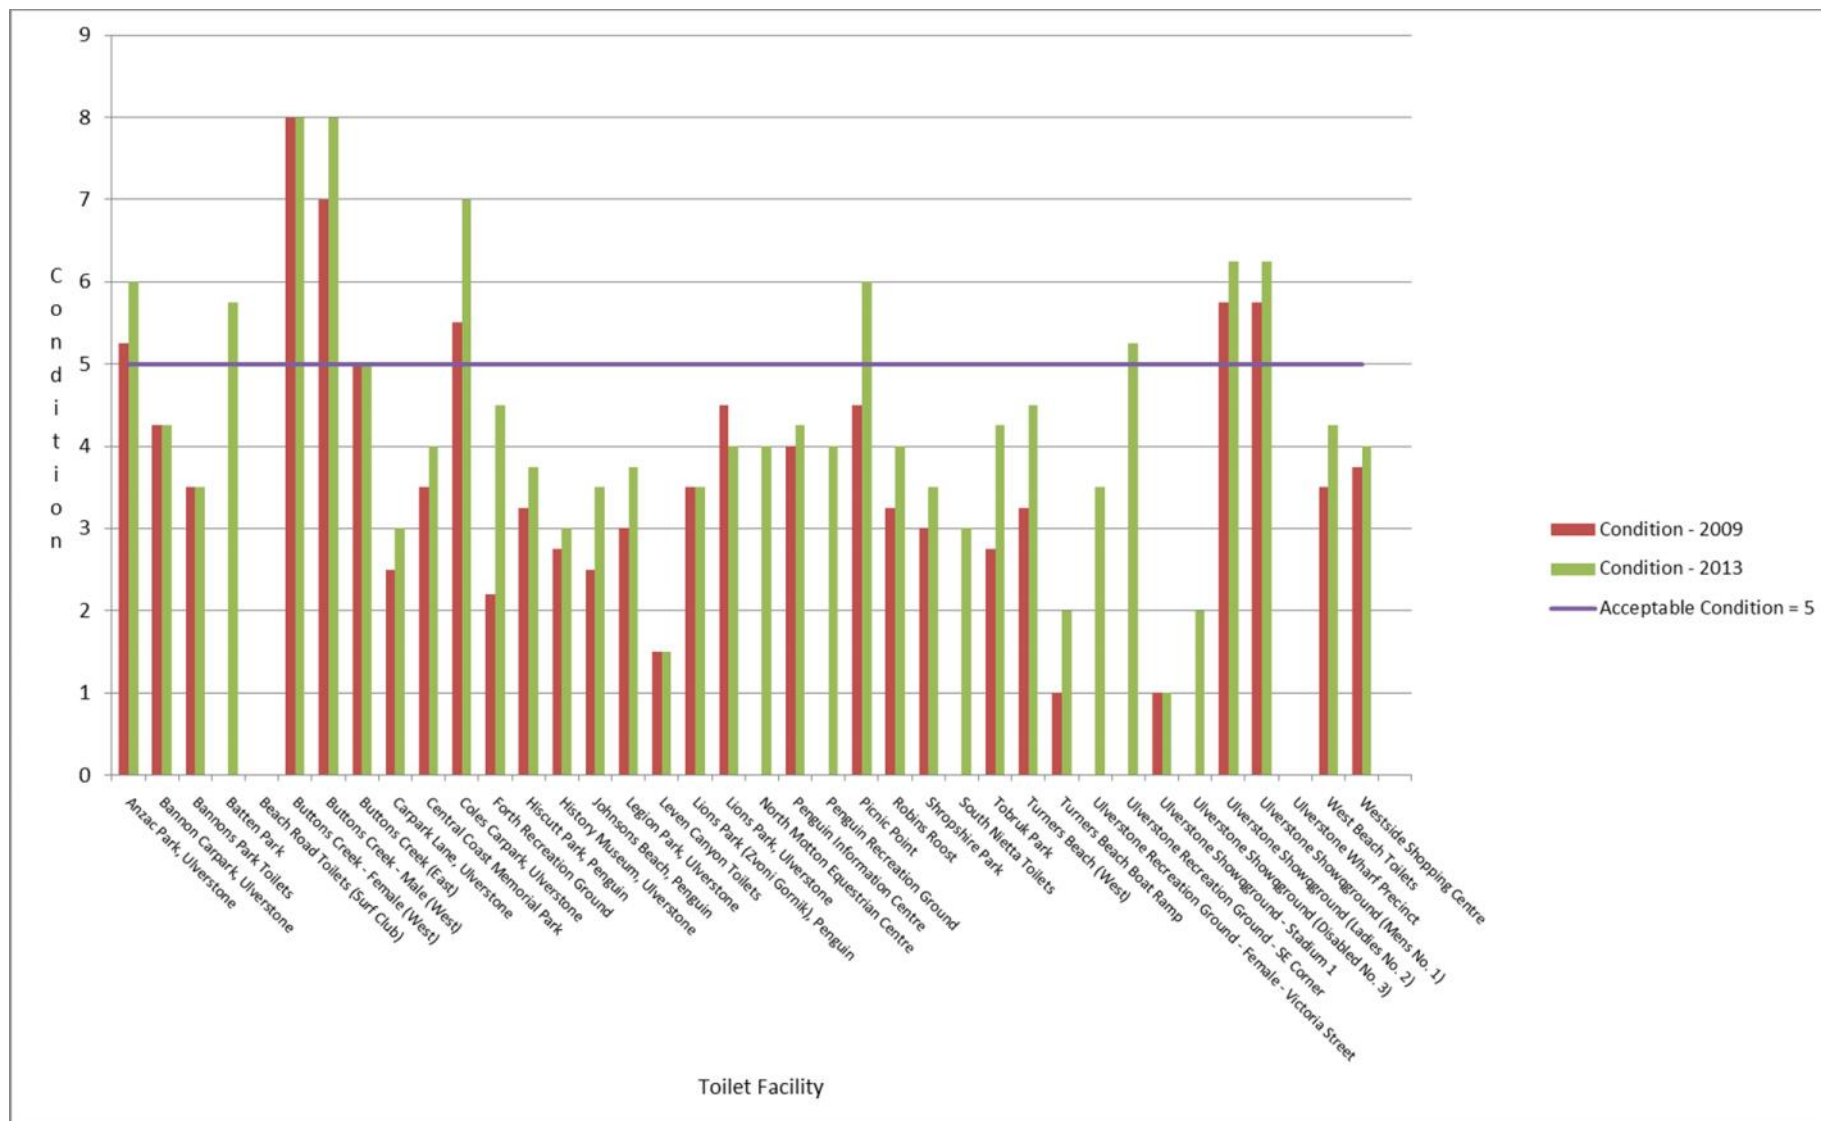
Appendix 9 – Condition Assessment

The overall condition assessment score was determined by rating for the floor, roof, internal walls, external walls and internal fit out.

In the four years since the previous condition assessment the condition of the toilet assets has deteriorated by approximately 15%.

For the condition assessment graph refer to Appendix 9.
