# Arboricultural Impact Assessment

Risby Street, Ulverstone, 2024

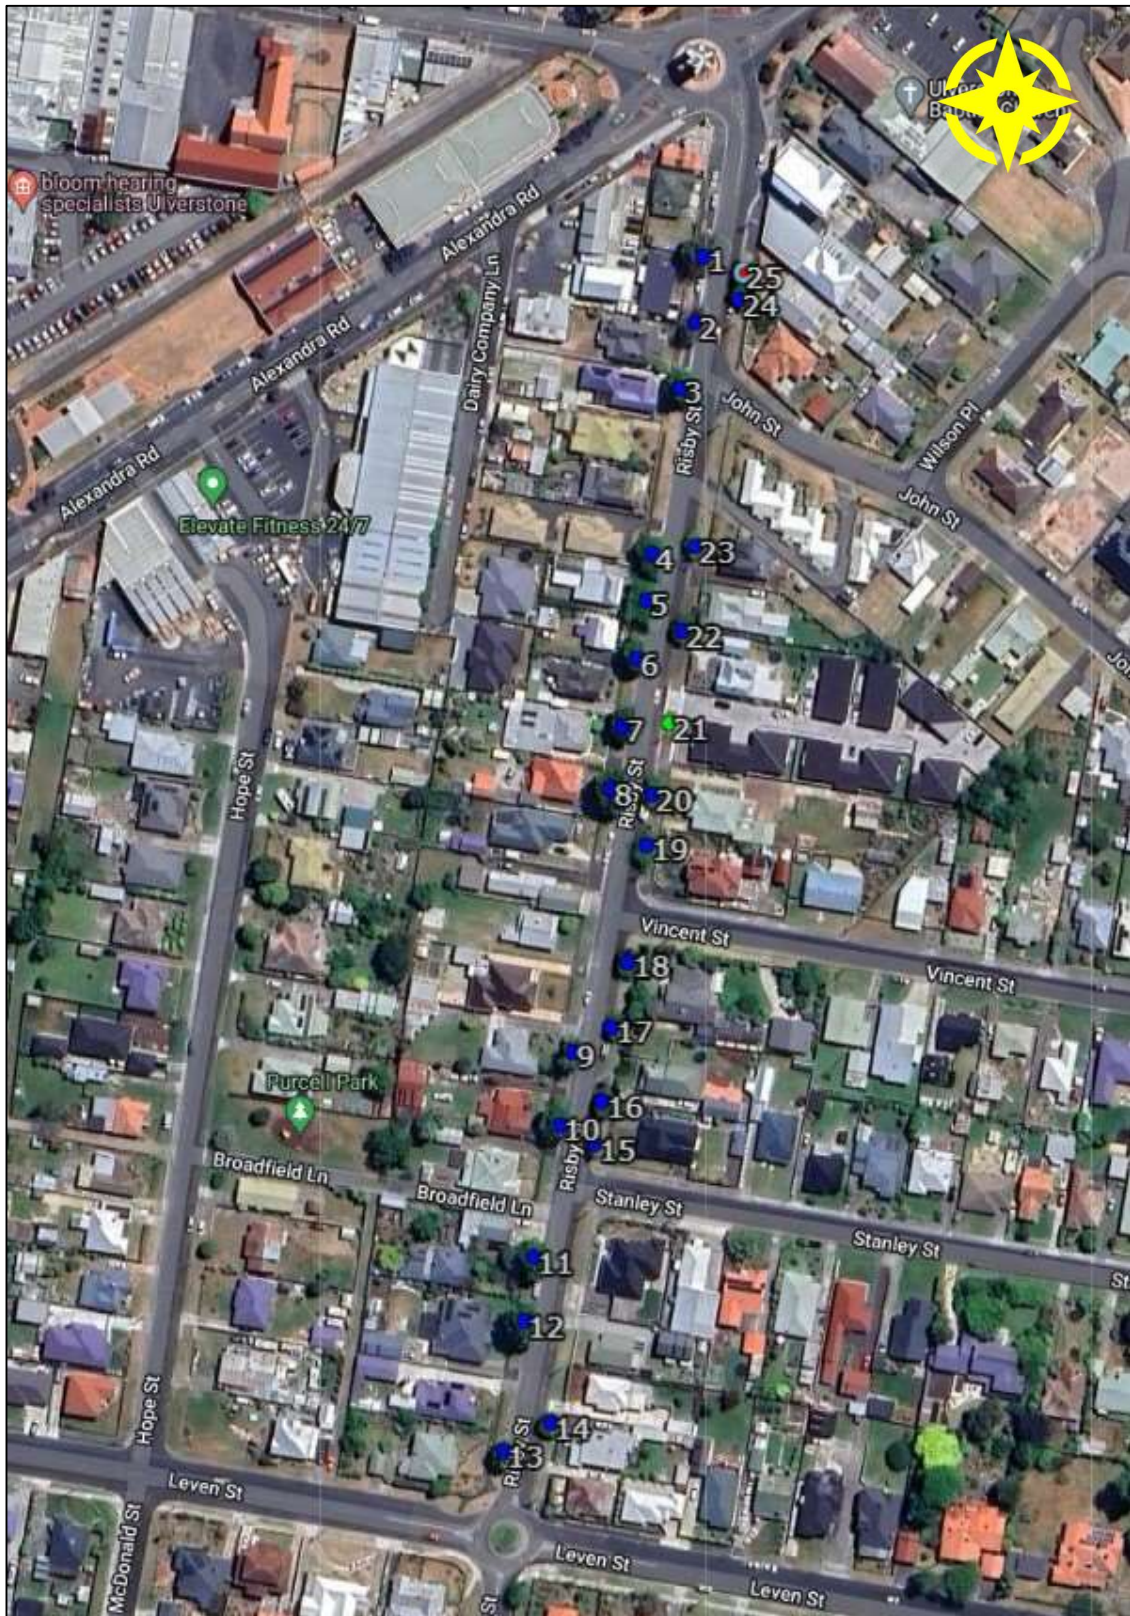
**Figure 1 – Tree Location Map**

The Arboricultural Impact Assessment evaluated 25 trees along Risby Street, Ulverstone, representing three species: English Elm (*Ulmus procera*), Crepe Myrtle (*Lagerstroemia indica*), and Willow Myrtle (*Agonis flexuosa*). Most of the trees were English Elms, with 23 individuals assessed, while only one Crepe Myrtle and one Willow Myrtle were present. The location of the assessed trees is detailed in Figure 1, while the full tree dataset is outlined in Table 1.
